**South Bethany relieved damage not worse
Ground-level houses on west flooded, but none are floating
News Journal October 31,2012**

Area Flooded by Sandy on 10/29/2012 – Shown in Yellow

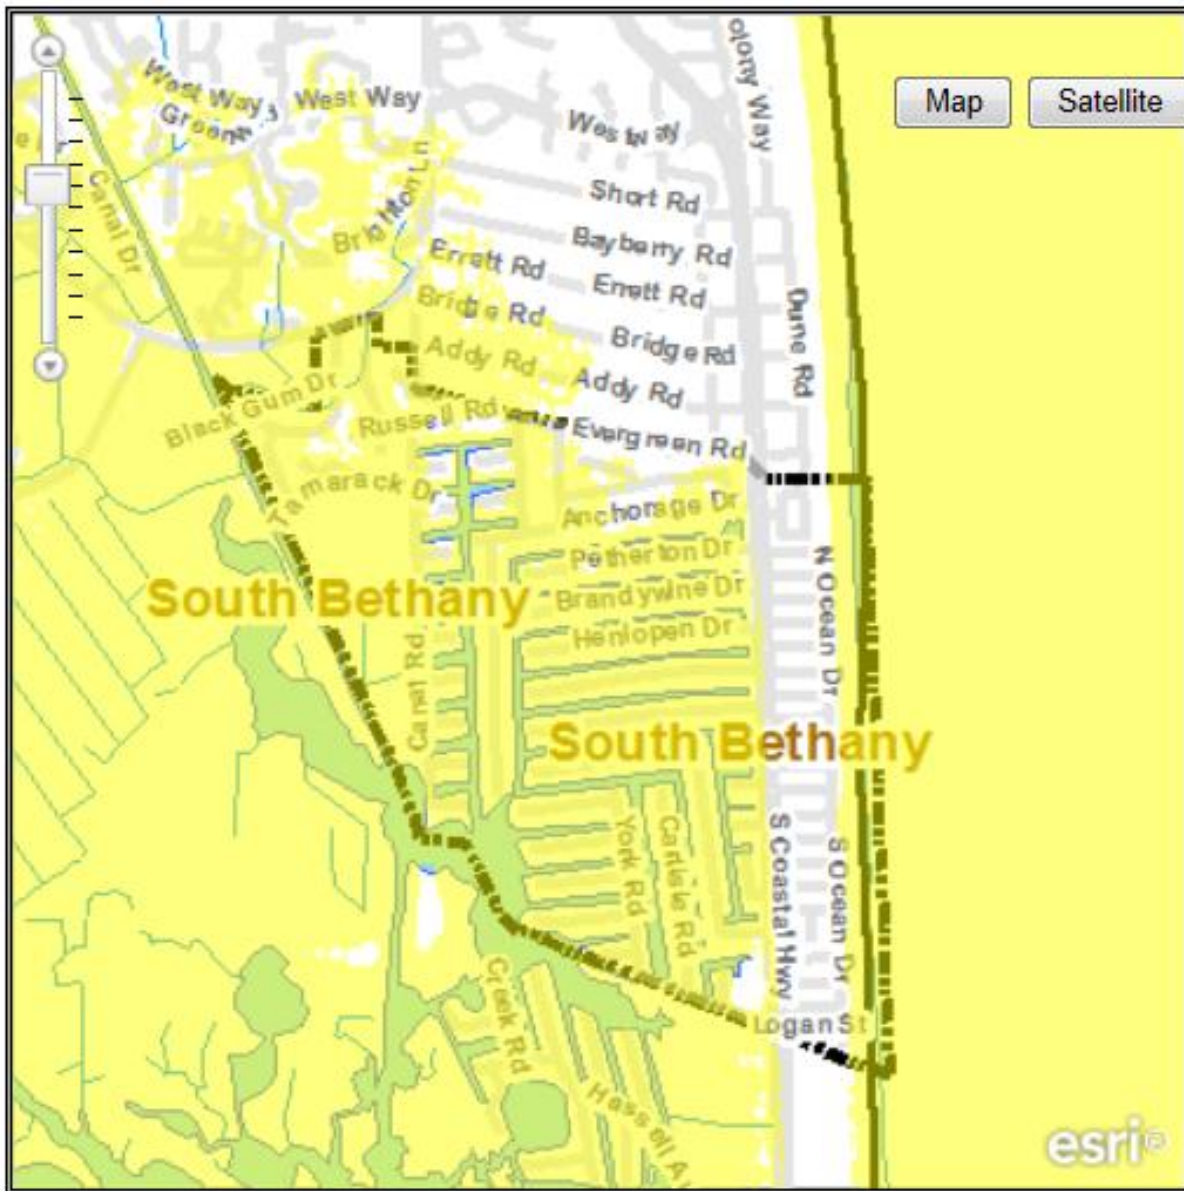
The water in the canals rose to 5.44 feet NGVD on the South Bethany Tide Gage at about midnight on 10/29/2012. This flooded many ground floors to a depth of about 2 feet. See next picture.

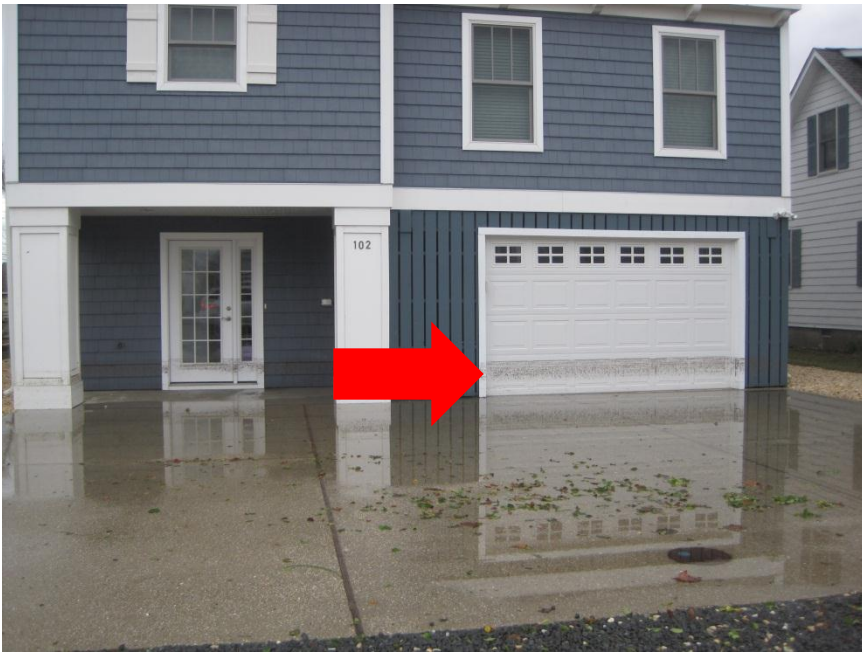
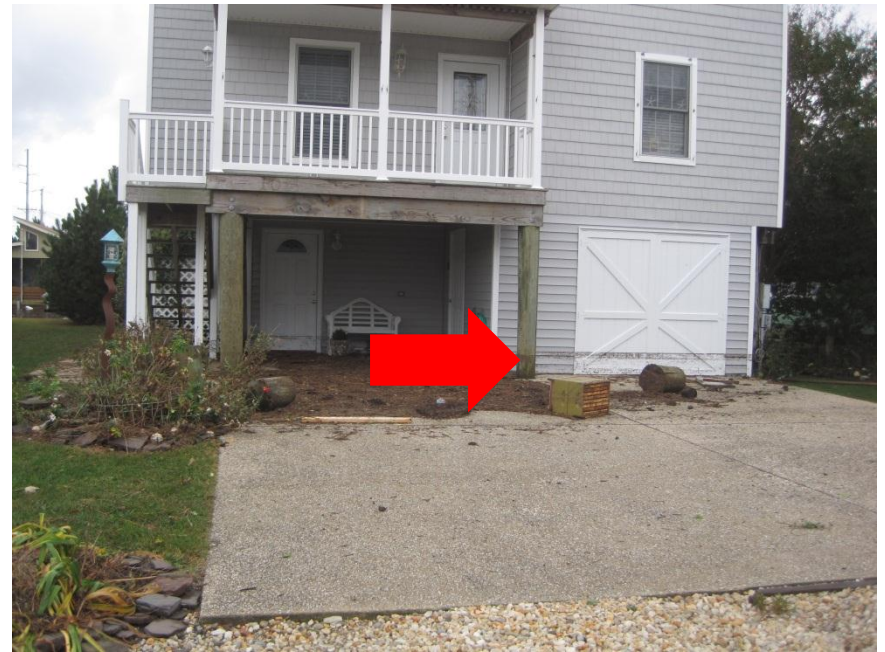
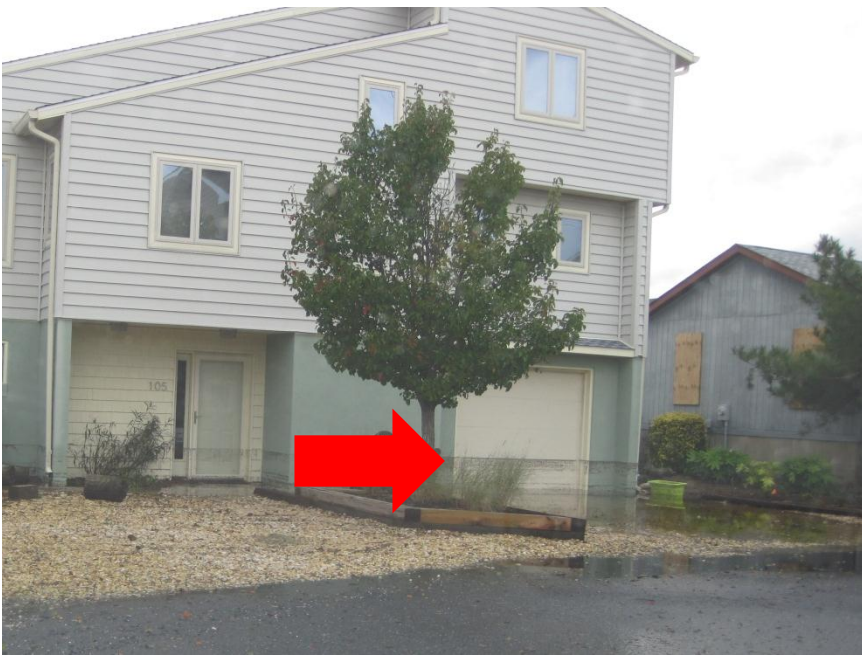
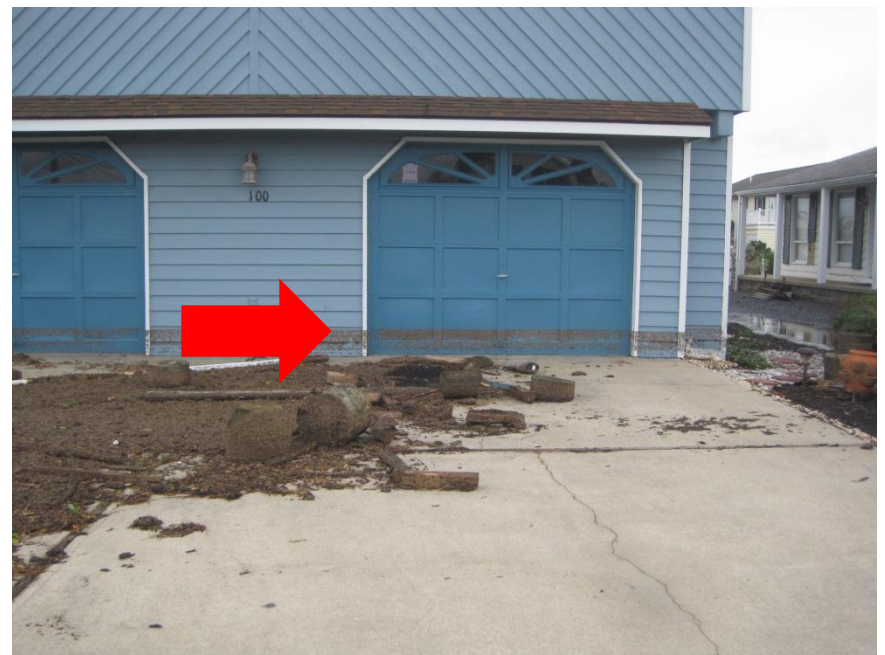
Note water level line shown on homes.
